LABORATORY MEASUREMENT OF THE REDUCTION OF TRANSMITTED IMPACT SOUND OF A FLOOR COVERING

Test report ID: T2019-1

Client: The Tile Warehouse Ltd.

Flooring wearing surface: KREM by SPC Flooring, engineered laminate flooring planks with foam backing: plank measurements: 1524 mm x 230 mm x 5mm
Instillation: Loose laid laminate click together flooring in a 3.2m x 3.2 m square configuration with offset joints as per standard installation
Total floor covering weight: 83.5Kg
Flooring sample dimensions: 3.2m x 3.2m

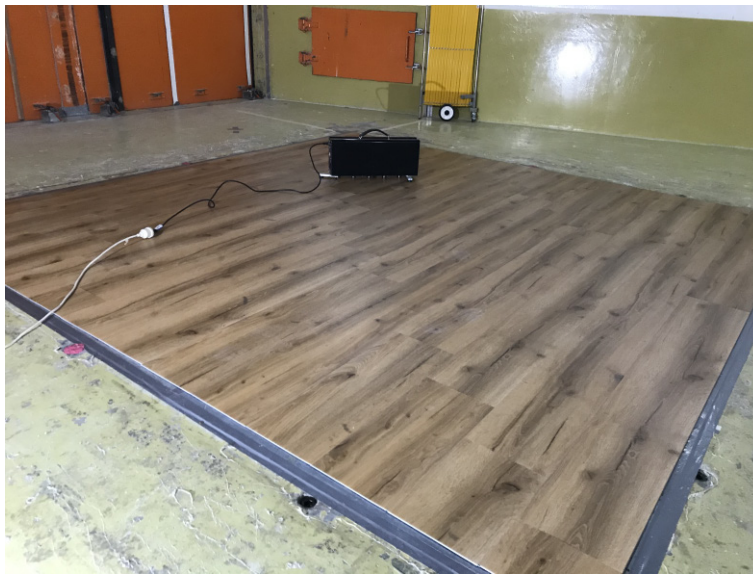
Figure 2.1: Flooring system installed on chamber floor
